**CHAPTER THREE**  
**REPRESENTATIVE ONE-ROOM BUILDINGS**  
**NEW CASTLE COUNTY**

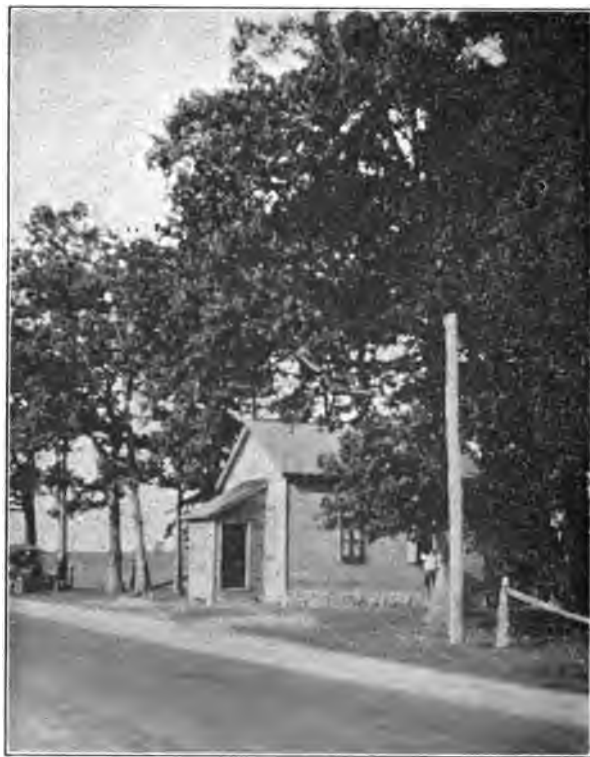
**FIELDSBORO SCHOOL**

points the building has. The building proper scores but 45 points in 200. The service systems are even lower in score than the very low score set by other buildings of the same general type. The class

room has nothing to recommend its further use. It is lighted from four sides. The blackboards are so poor as to score but 2 points out of 15 and the seats and desks but 2 in 30. The building should be closed and the children transported to a better building.

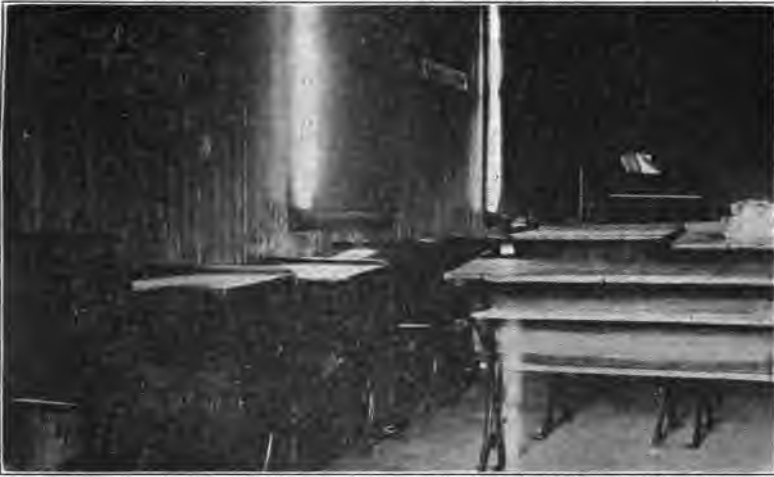
### BLACKBIRD, DISTRICT NO. 69

*Building.* Small, very old and in a deplorable state of repair.

*Service systems.* An attempt to heat the building is made by means of a small stove located in the center of the room. The open cracks in the doors, windows and walls make this impossible to such a degree that in cold weather school has to be dismissed. The building is in a filthy dirty condition. There is no clock in the building and a water pail is all the evidence of a water supply system. One toilet was without a toilet seat. The scholars had made use of the floor of the toilet room and the fuel shed for toilet purposes.

benches can be rated as seatings, are provided for 45 children in a room 18x27. In order to get this number of seats in it has been necessary to place the seats squarely against the walls on both sides of the room. This arrangement precludes the possibility of side aisles or the use of the side walls for blackboard space. The accompanying picture shows the lighting conditions which the children so seated are compelled to suffer. The survey commission wishes to place special emphasis upon the recommendation that this building be closed.

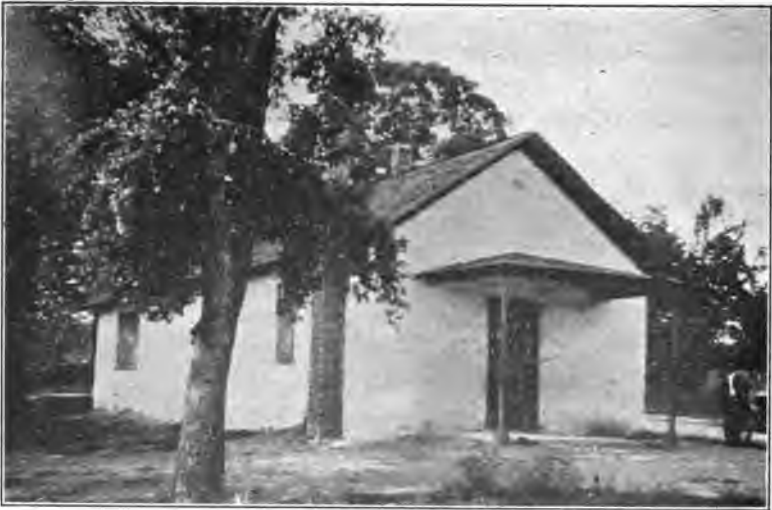
**SHELLPOT NO. 73**

of the room, makes no provision for drinking and washing. The toilet facilities are of the poorest type and in bad condition. The room is lighted from four sides.

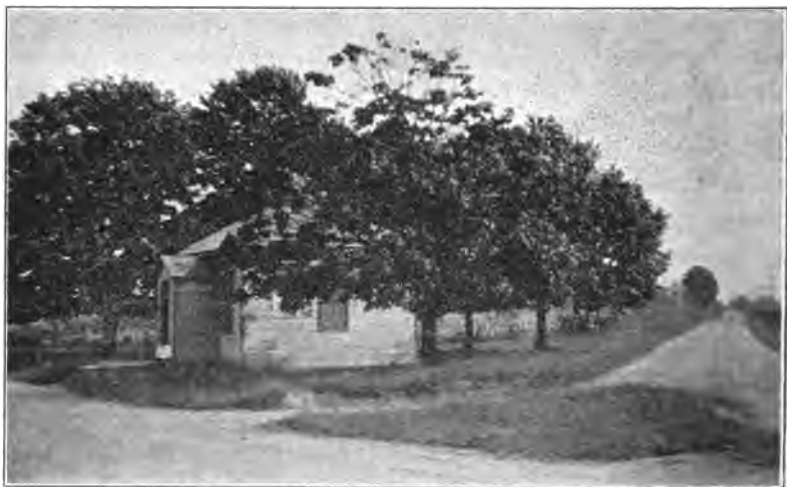
**MILL LANE SCHOOL**

The Mill Lane building is 18 feet square, seating 16 pupils, and located on a little triangular plot of land in the fork of the road. It does not fly the American flag. It is heated by a stove in the center

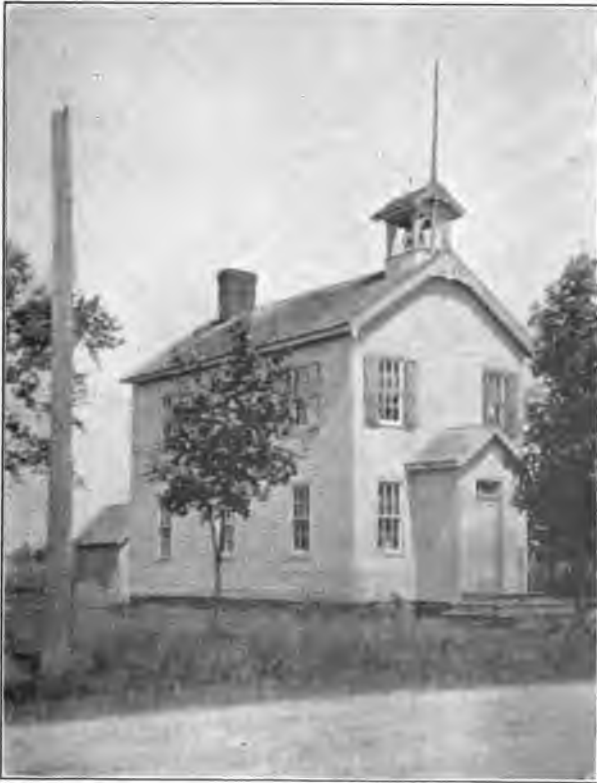
HARTLY SCHOOL

The Hartly School is housed in a very old two-story, two-room, frame building, in poor condition. The building is located on a very undesirable, unattractive site. The improved type of heater, thirty-eight new single seats and the good pictures which have been secured for the building represent its only commendable features. The number of children in attendance at this school would seem to justify the recommendation that a more adequate provision be made for a modern educational program.

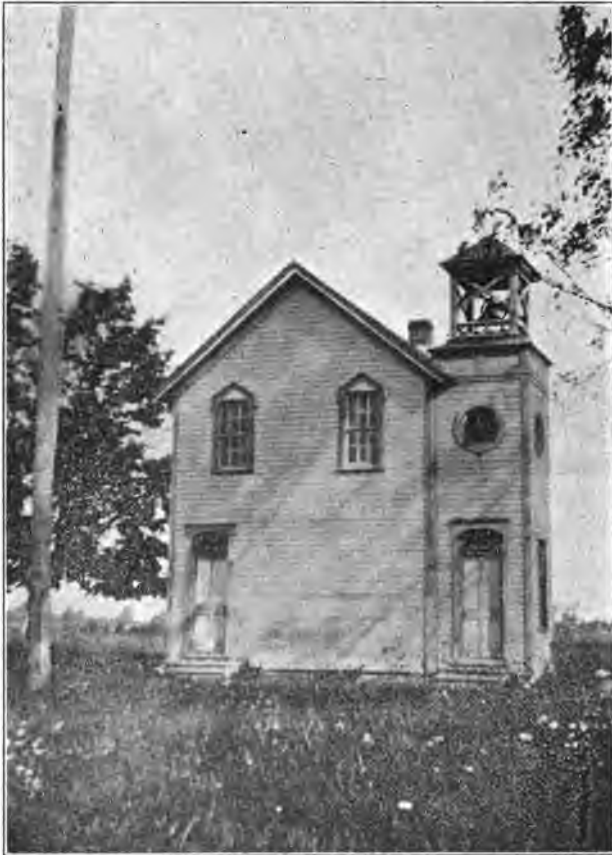
**CANTERBURY SCHOOL**

This two-story, two-room structure is located on an open rectangular lot which can be used for play purposes. The interior of the building would be a disgrace to any community. Plaster has been broken from the walls in many places; blackboards have been

torn down; furniture roughly treated, and the roof has leaked in places. Apparently no respect is paid to public school buildings by

the school children of this community, and probably this building with its equipment and cheap construction is entitled to little respect. The building has no attractive feature about it.

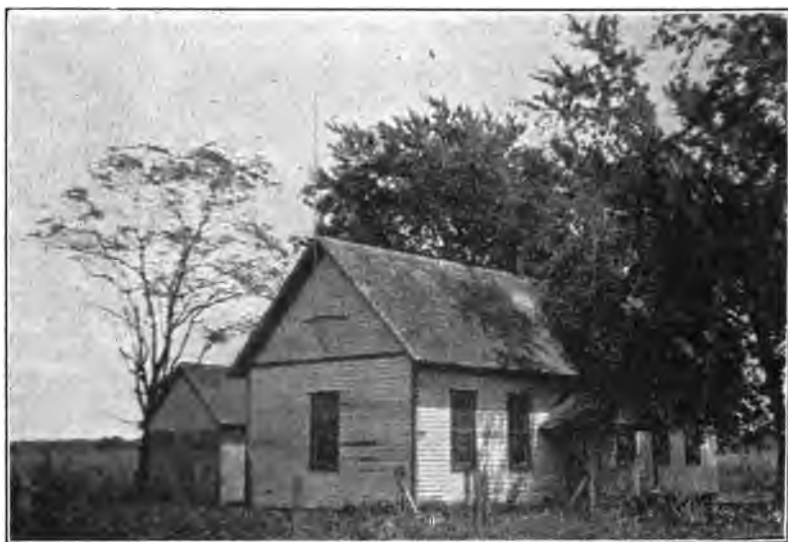
### BETHESDA NO. 46

This is a two-room, one-story, frame building, located on a triangular site, the base of which is 100 feet, and the length of which is approximately 200 feet. The building is very old and poorly preserved. It offers the absolutely minimum of room space, and the service systems are of the lowest type which will permit of the assembling of children in groups. The class rooms are inadequately equipped, and the lighting arrangements are especially bad, one room being lighted from three sides. The fuel room, which from an educational point of view is perhaps the least essential, is the best feature of the building.

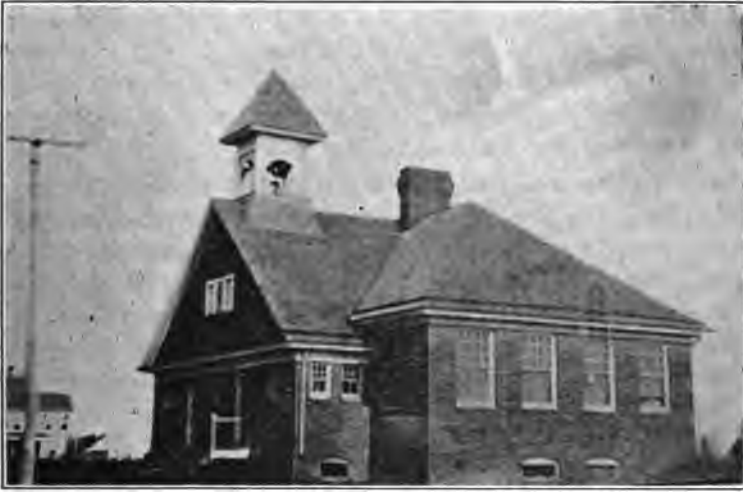
### VIOLA NO. 112

actual needs and is undeveloped for recreational purposes. The building is cheaply constructed and certain very fundamental errors are outstanding. The foundation walls are but eight inches thick, and standing as they do in soil that is partially quicksand the building has settled out of line and considerable damage has already been done to the walls and building.

The building is provided with inside chemical toilets, which are in fair condition and apparently sanitary. It is to be noted, however, that but one toilet is provided for each sex. This, for a school of two large rooms is not sufficient to meet the needs of the pupils. The only way in which this building can be made to approach acceptable standards is by considerable alteration and extension of the building proper and development of the site upon which the building stands.

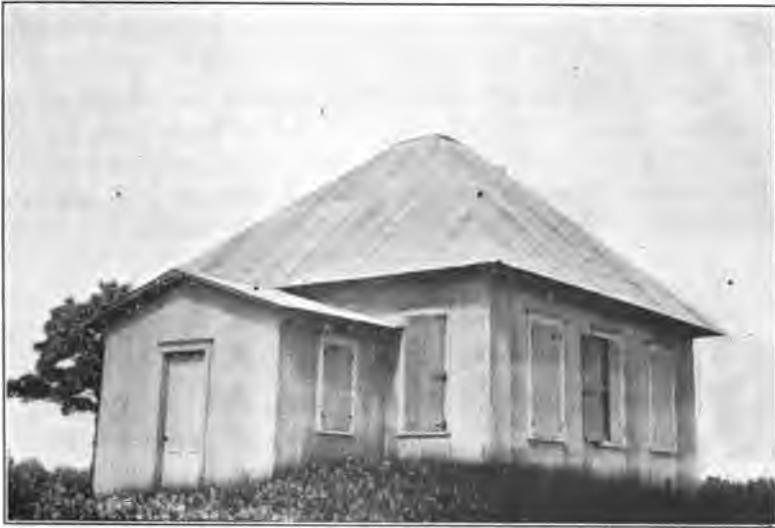
#### WHITES CHAPEL NO. 10

Whites Chapel is a new one-room structure, 20x22 in dimensions, with vestibule. It stands on a brick foundation. The site upon which the building is located is irregular in shape, approximately 100 feet in width and 300 feet in length. This building is a very unusual type of school building. It is made completely, walls and roof, out of corrugated, unpainted iron and resembles a garage rather than a place in which children are to receive their educational training. It does not speak well for the attitude of the community towards education or the welfare of their children. Apparently it is the cheapest type of construction which could be found. An improved type of heater is located in this building and water is supplied by a pump located in the vestibule. The class room, which seats 32 pupils, is entirely too small and of unapproved shape. The glass area is up to standard but distributed on three sides of the room. The vestibule provides space for cloak rooms, but as such is not acceptable.

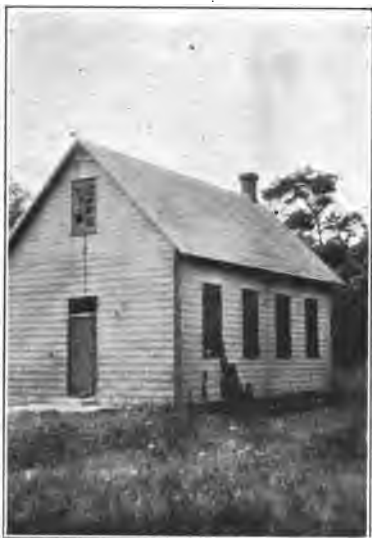
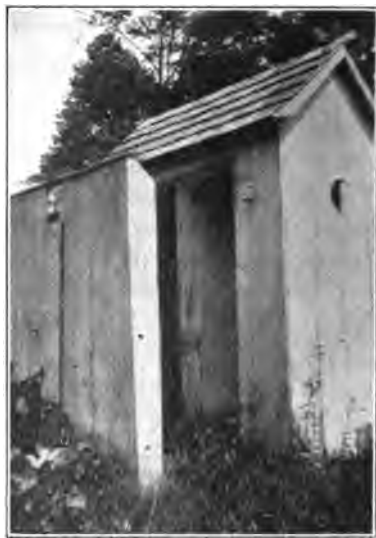
**ELDORADO SCHOOL**

This building, 18x28, situated on a site of indeterminate area, has concrete steps leading to its front door. The floor of this building is poor, the shades in bad condition but excellent book and sup-

ply closets are provided. Provisions for seating 40 children in double seats were found. The teacher's desk was of a fair type and slate blackboard is provided in sufficiency. No clock and no pictures were to be found. The building has a sufficient amount of window area, half of which, however, is in the wrong place. The only out-

house for this school is a combination of two compartments, separated by a wood partition, each one of which was apparently designed for the different sexes. That such a combination of outhouses is not a desirable method of raising the moral tone of children, nor of teaching them sex education was quite evident from the obscene drawings and foul language with which the interior of these outhouses was coated.

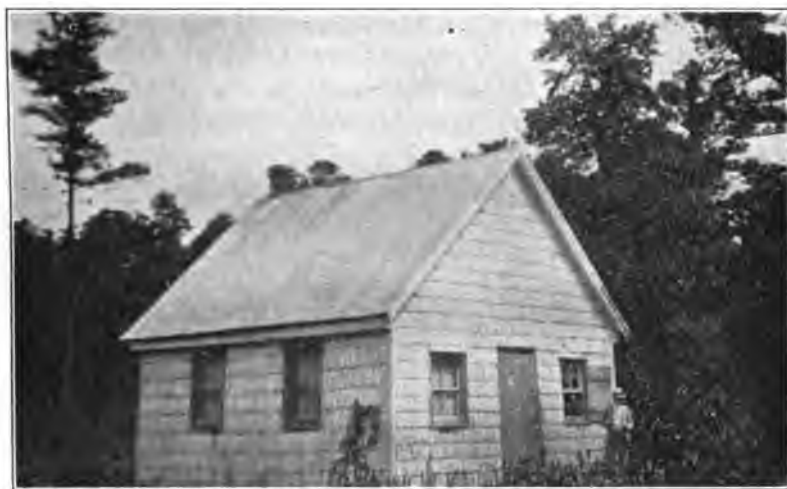
**HILL'S NO. 21**

The Hill's school is situated in a little clearing with forest to the right, rear and front, and an open field to the left. It is a whitewashed, shingle structure which is decaying rapidly. It has a roof of corrugated metal and a foundation of rotting wooden posts. The room is square, being approximately 18 feet each way, and is lighted by two windows on each of three sides. Even though lighted on three sides and even though the room is small, these six windows do not furnish more than half of the percentage between the window area and floor area that is considered to be the standard. A box wood stove, without jacket, is located toward the front center of the room. The seats are placed on stilts and occupy a large part of the class room. The floor is in fair condition, but only a distance

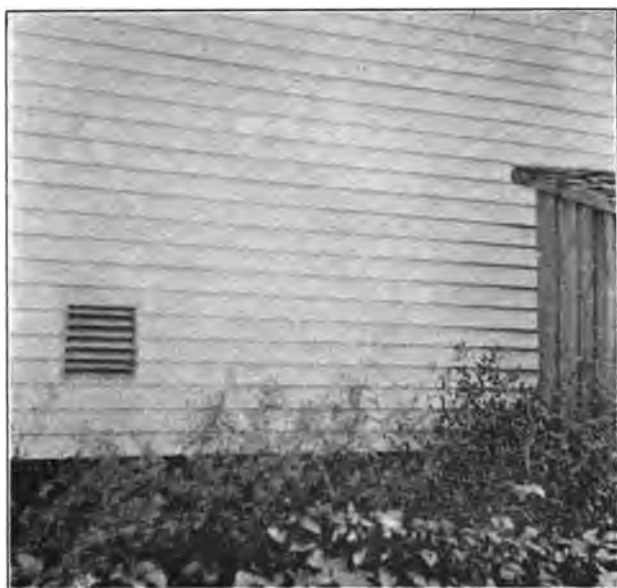
### TRINITY NO. 73½

The Trinity school is a new one-room frame structure, without vestibule, on a brick foundation, approximately 24x32 in dimensions, standing on a small irregular site surrounded on two sides by open fields and on the third side by woods. The site, though unsatisfactory, is capable of extension and improvement should this prove to be the logical point for the location of the school building. The building proper is well painted and in good condition, and is supplied with an improved type of heater. The interior finish of the

class room is comparatively good and the blackboard space and equipment is better than the average found in the county. The glass area is low and the windows are distributed on two opposite sides of the room. One feature of this building is especially bad and should be corrected immediately, namely, the location of the toilets with respect to the air intake of the jacketed heater. The toilets, which are of the double compartment community type, are located  $2\frac{1}{2}$  feet from the rear of the building and six feet from the air intake. This condition undoubtedly supplies the class room with foul-smelling, impure air. It is inconceivable that intelligent workmen would locate the toilets or the air intake in such positions. This district could easily and practically consolidate with the adjoining districts.

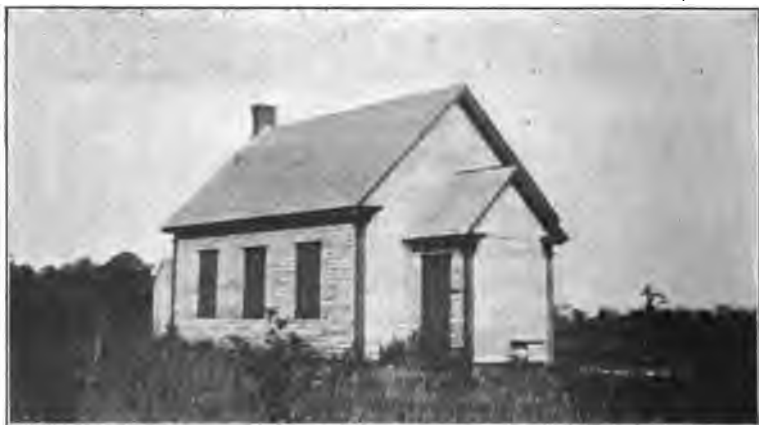
#### FAIRMOUNT NO. 82

Fairmount is a one-room structure with a ramshackle exterior but fair interior. It is located on an unattractive piece of land at a point where it does not appear to be accessible to a large number of children. It has an improved type of heater, wainscoting and pine board ceilings, and fair children's seats, although they are of the double variety. The toilets are located directly in the rear of the building and in close proximity to one another, without any barrier.

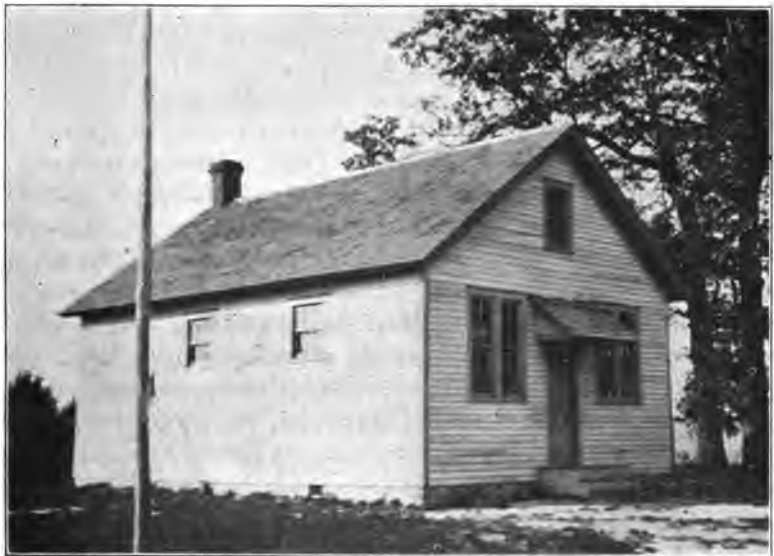
**JOHNSON'S NO. 85**

This school is a new one-room, frame building, 21x32, with concrete foundation and vestibule. It is located on a site approximately 100x150 feet, which is in good condition and well kept. The building is located on an excellent highway and is easily accessible. An excellent type of vestibule providing fairly satisfactory cloak rooms is included in the structure. The service systems, however, are much below the standard of the other features of the building. The class room is heated by a common stove. A pump is installed in the building. The outside toilets are in rather better condition and of better quality than found in other districts. The class room is the best feature of the entire situation. It is of good size and well shaped. Unfortunately the interior is finished in wood. This is not a standard type of finish. The blackboards are excellent and the glass area is adequate. The window area, in so far as the building plan is concerned, is not extremely bad. The windows have been banked on one side and three small windows have been placed high up on the opposite side of the room. These windows would not be seriously objectionable were it not for the fact that utter ignorance and stupidity have been shown in the arrangement of the seats. The seats and desks have been backed to the main source of light, thereby compelling the children to face all day long the two high windows in what has been made the front of the room. The seats should be turned in such a way as to place the main light source on the left of the pupils and the blackboards should be moved from the side of the room to the front. The seats and desks are of the single type of good quality and well selected as to size.

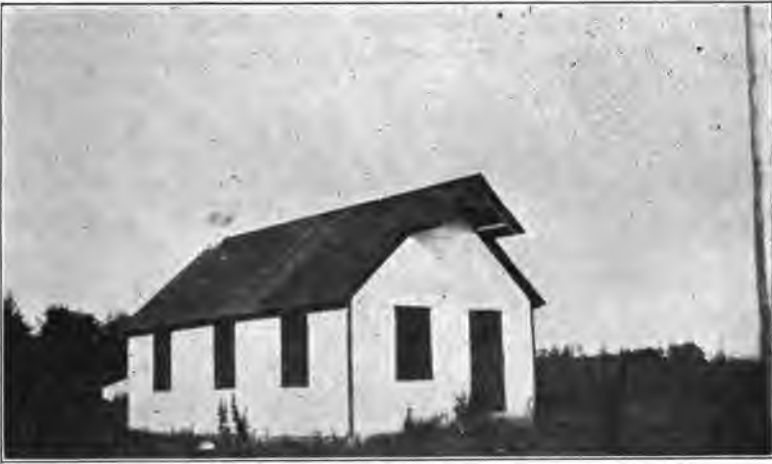
**MUDDY NECK SCHOOL**

This is a very old one-room, frame building, without vestibule or protected entrance. It is approximately 15x24 in dimensions, located on a triangular site, too small to allow for any recreational program. It is in very bad state of repair and presents every poor feature, from lack of service systems to lighting on three sides. The equipment is inadequate, the only feature thereof which is at all passable is the provision made by the installation of new double seats. Double seats, however, are not acceptable under modern educational standards. If consolidation cannot be effected for the children of this district a new one-teacher school, built on modern lines, should be provided.

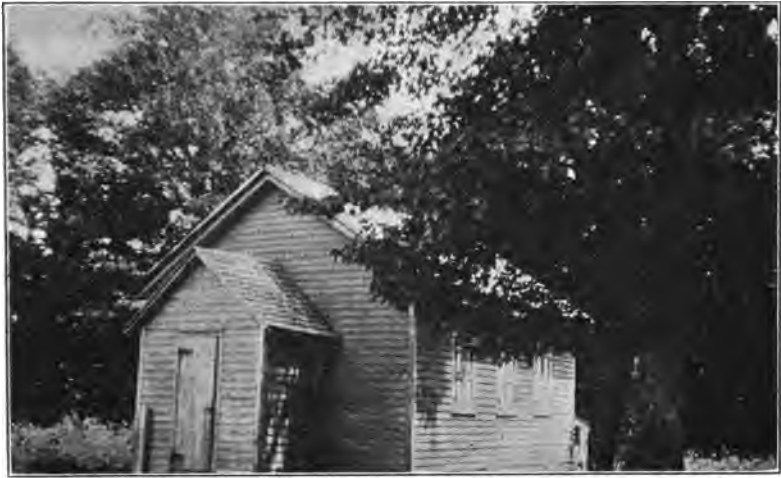
HOLLYVILLE SCHOOL

The building is 20 ft. long by 16 ft. wide and rests upon a brick foundation. It has a corrugated metal roof upon which the rain no doubt beats down to the disadvantage of school discipline. Two rows of single seats have been provided besides the double seats that are in use in this building. Apparently the only reason why single seats were provided was because the building was too small

for double seats, as the single seats have been placed against the wall even where the dead wall spaces are to be found between win-

dows. The building would make a fair sized woodshed but is altogether unsatisfactory as a schoolhouse. Its outhouses are in wretched condition and in close juxtaposition to each other and the school. One outhouse may be reached by wading through water at certain times of the year.

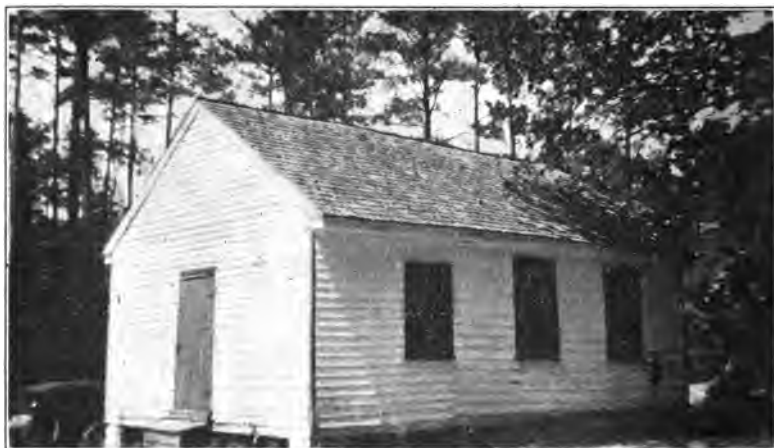
MCNEAL'S SCHOOL

The McNeal's school, locally and more appropriately known as "Hog Yard," is a one-room, frame building, approximately 16x22 ft. in dimensions, located in a small irregular, triangular clearing in an oak woods. Except for the narrow unimproved roadway running by the building the site is surrounded on all four sides by dense woods. The building is very old and in a very bad state of repair. The roof is moss grown and the open brick foundation offers little support to the building and no protection against cold winter storms to the floor of the class room. The site is too small and impossible

of extension or improvement to meet standard requirements. The interior of the building, except for the improved heater is of the type one might have expected to find in the pioneer schoolhouse. It is dark, dirty and untenable for human beings, unless, as is the case with school children, they are compelled by law to attend. The meager equipment is of the poorest type and much abused. Old double seats badly carved and mutilated are extremely unsatisfactory, and the teacher's desk is of the same general character. The glass area is low, and the windows are placed on three sides of the room. There is no justifiable excuse for the use of this building for school purposes, and in the light of modern civilization it should be condemned and closed. The pupils should either be provided with a modern one-teacher school or transported to a graded school at some point agreed upon with neighboring consolidating districts.

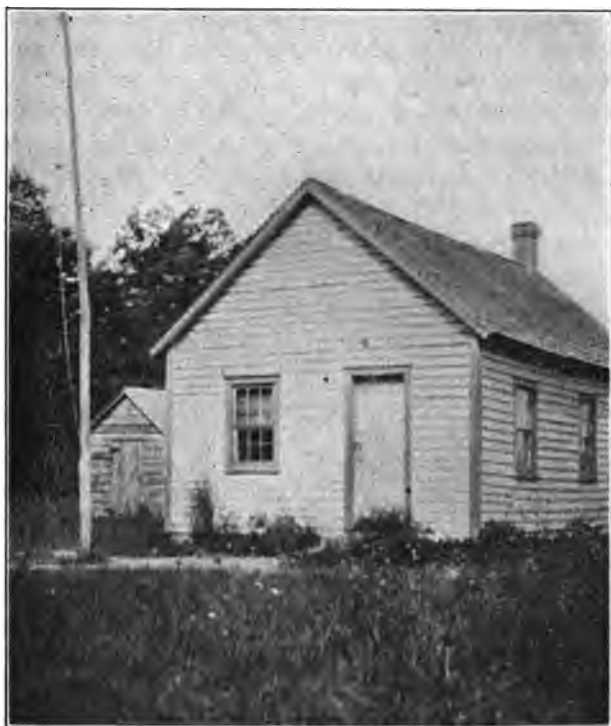
### FOREST PARK NO. 179

This is a very old one-room frame structure without vestibule. 15x28 in dimensions, located on a lot approximately 30x100 ft. in a pine woods. The building is in a very bad condition and not suitable for improvement or worthy of consideration or enlargement. It is heated by a common wood stove which has a sheet metal jacket.

It is poorly kept and the outhouses are poor in quality and insanitary in condition. The class room is the traditional four wall affair, with absolutely the minimum of equipment. The glass area is low and distributed on the left, right and front of the room. The nine square feet of blackboard space provided is to serve 30 pupils. Such a situation can call for but one recommendation, that being the speediest possible abandonment of the site and building for school purposes.

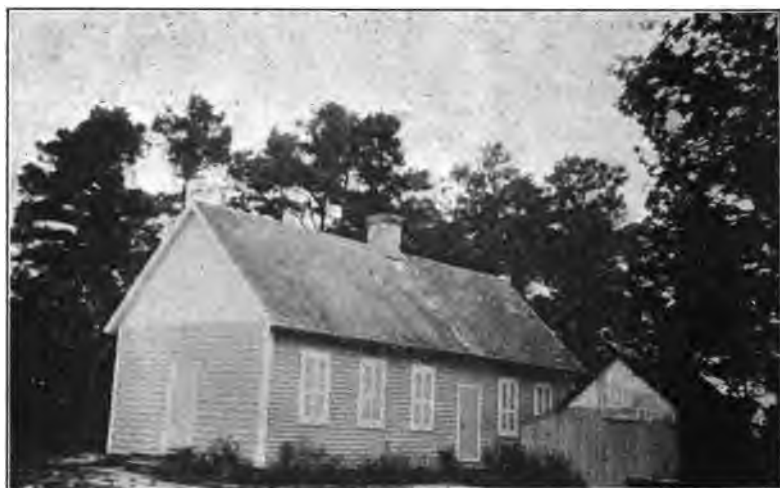
#### MIDWAY NO. 179

attempt to meet crowded conditions of a one-room school by stringing out a second room on the end of the original one-room structure. Apparently no expert advice had been sought in the construction of the building. The building is heated by an improved type of jacketed heaters, but the other elements of service systems are extremely poor. The toilets are located down in the woods where they are almost inaccessible. The class rooms which are approximately 18x22 and 18 feet square respectively, are poorly equipped and poorly lighted. As soon as the necessary steps can be taken to perfect consolidation so as to bring together a larger number of children in order that a graded school may be had, this school should be closed.

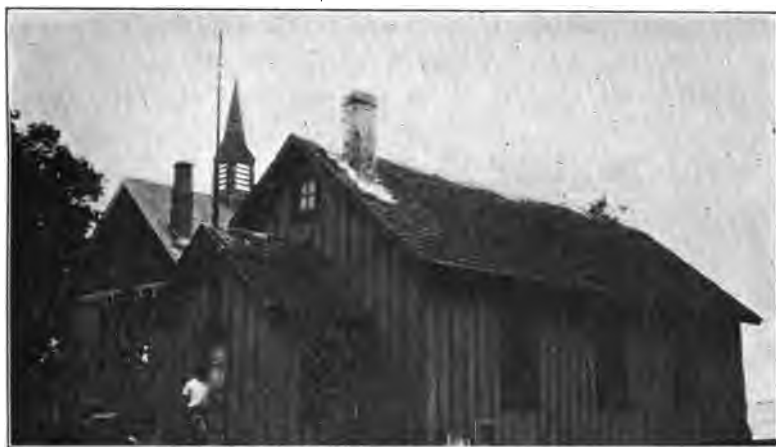
**NEWPORT SCHOOL**

The Newport School for colored children is a one-room, rectangular, frame structure, very old and in poor condition. The environment of this school is a church, graveyard and potato patch. The site is scarcely larger than the building itself, and the entire situation is most deplorable. It is unfit in every respect for the housing of children.

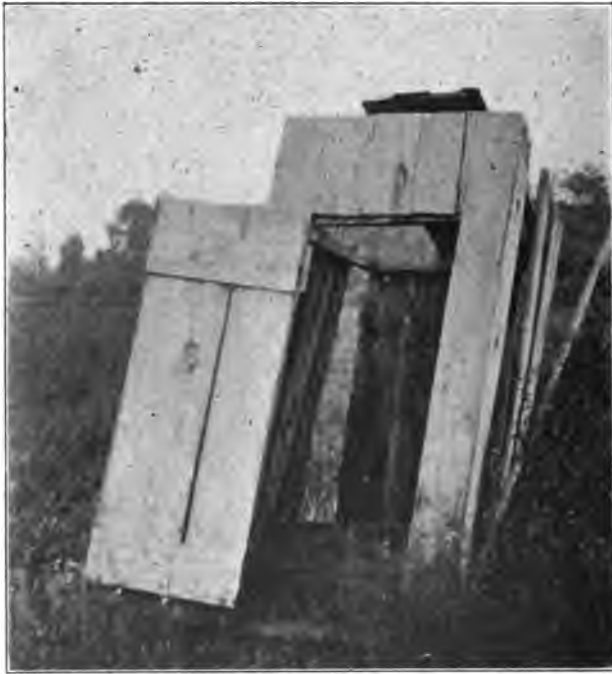
**THE TOILET FOR THE COLORED CHILDREN OF THE WILLIAMS-VILLE SCHOOL, DISTRICT NO. 113, NEW CASTLE COUNTY**

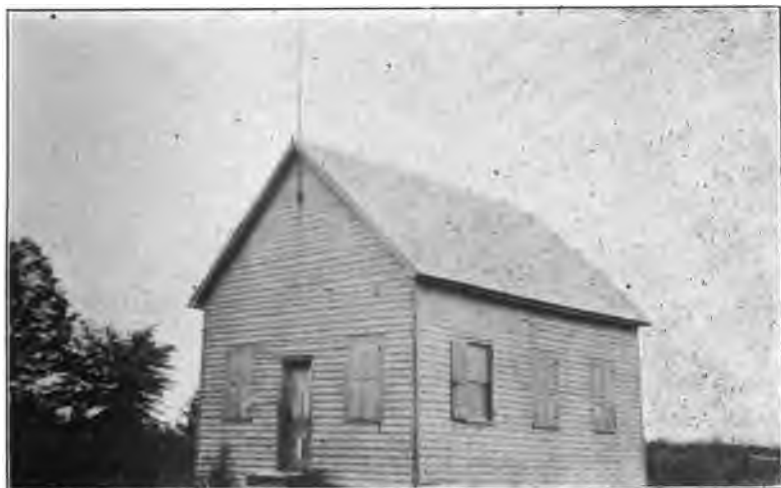
### GLASGOW NO. 114

The Glasgow School is a four-walled, frame structure, without vestibule or protected entrance. It has a tin roof and is in general

bad state of repair. It is located on a small triangular plot of worthless land adjoining low, swampy ground. On no single item considered does the building justify its use for school purposes. The total score of 209 out of 1000 justifies the recommendation that this building be closed to school children.

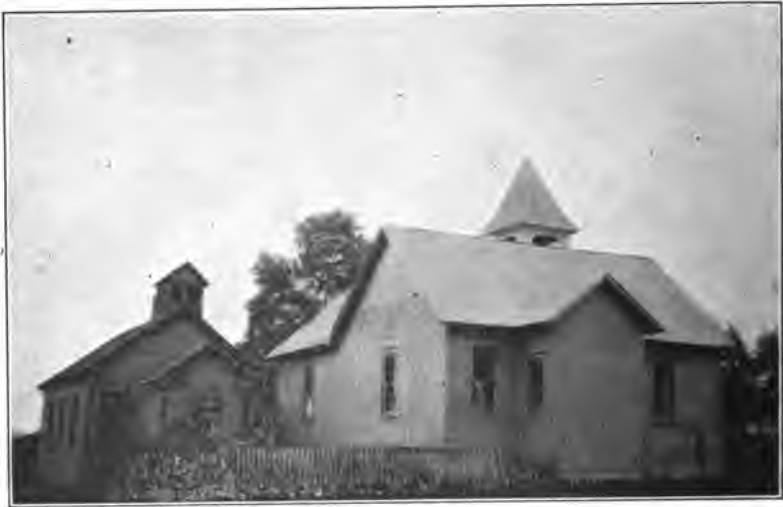
**SCHOOL HOUSE**

The school for colored children in St. Georges is a one-room, rectangular, vestibuled type of frame building, located on a small

site in the rear of the colored church. As clearly shown in the picture, there is no opportunity for play and little possibility of the development of an adequate recreational ground. The building is poorly equipped, poorly lighted and unfit for school purposes.

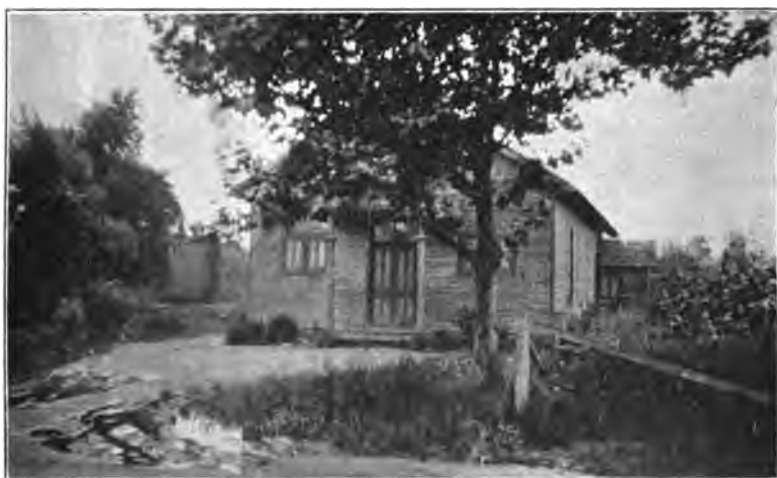
### DELAWARE CITY DISTRICT NO. 118

NOTE--Marsh to the left with Canal boat back of it

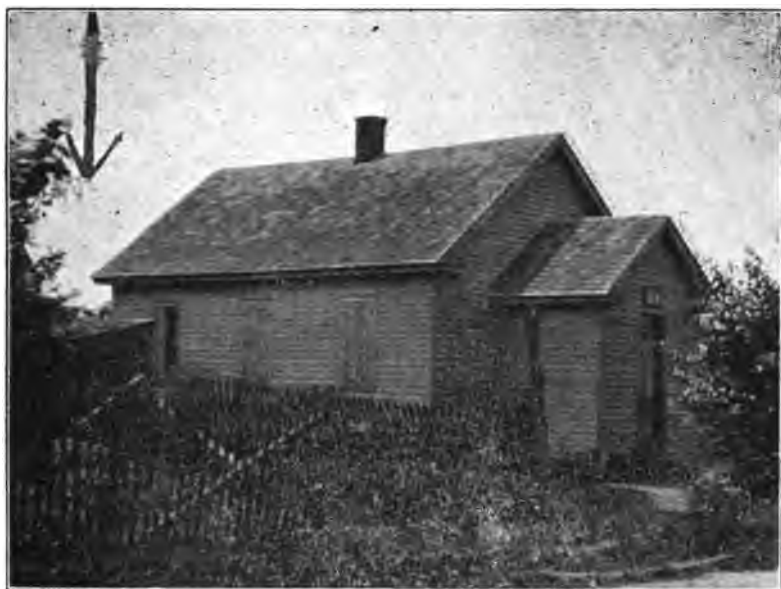
### MT. PLEASANT SCHOOL

Shelter and to a degree protection from cold, inclement weather is all this building has to offer the children that are supposed to attend it. It is disqualified and condemned on every major item of the score card and reference to the detail scores will further emphasize the educational lacks. It is of special note that this building has but one toilet for the two sexes and that in the class

Note arrow to the left of school house pointing to pig sty.

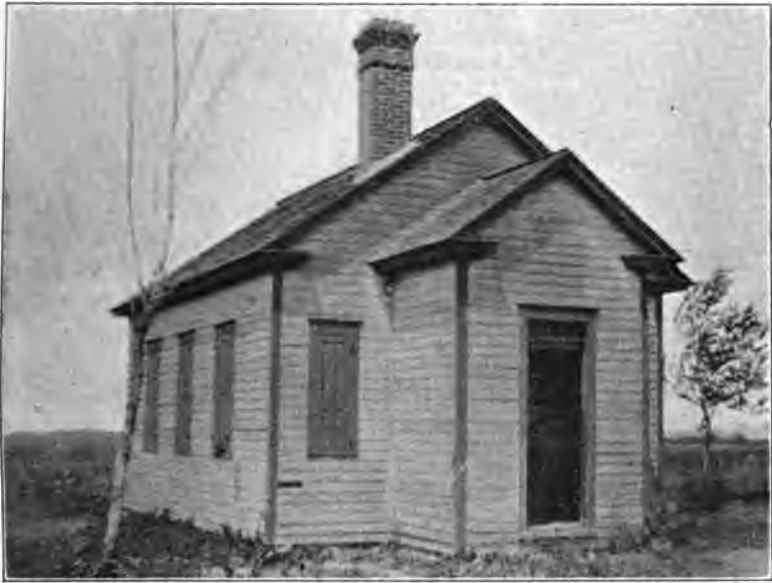
**PORT PENN SCHOOL**

Altho scoring above the medium for colored schools of the country, the Port Penn building is in every major respect far below acceptable standards. If the present location of the school should appear to be the most satisfactory, the size of the site should be extended by from four to ten acres and a properly planned building constructed. It seems fair to note that this colored school did have two toilets, altho they were in very unsatisfactory condi-

tion. The building is heated by a jacketed heater of good quality and in this respect is better than others of its class.

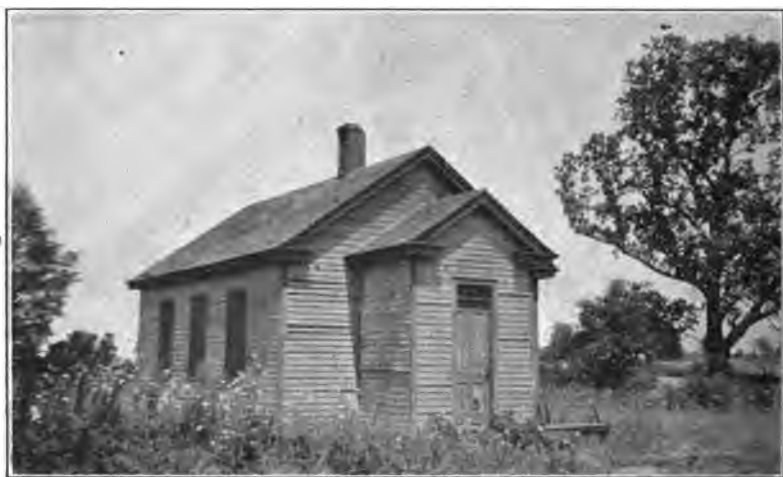
**CONGOTOWN NO. 123**  
(Colored)

This building has nothing commendable about it except the improved highway which makes it fairly accessible. Its environment is not pleasing; the site is so small as to be of no consequence and the little that is not occupied by the building is overgrown with briars and bushes. The two sexes are provided with but one toilet, the condition of which is very bad. The adequacy of the class room is indicated by the very low score of 57 points out of 225. The building should be closed for school purposes and the site abandoned.

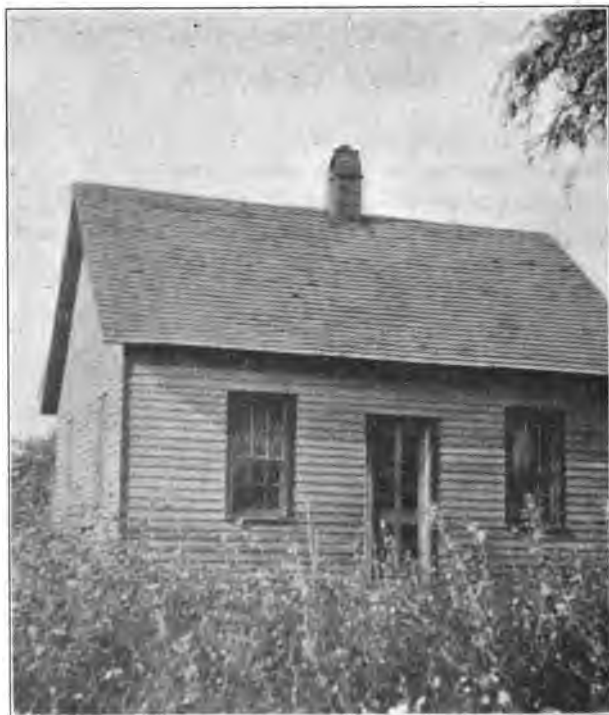
**BLACKISTON'S NO. 137**  
(Colored)

This is a one-room frame building with unprotected entrance on the long axis of the building. It is in a dilapidated condition, and the entire surroundings are unsuited to the needs of the community. The grounds are overgrown with briars and bushes, and the entrance to the grounds is so low that at the time of the survey the building was almost inaccessible. The class room is lighted on three sides and is supplied with the very minimum of ancient and mutilated equipment.

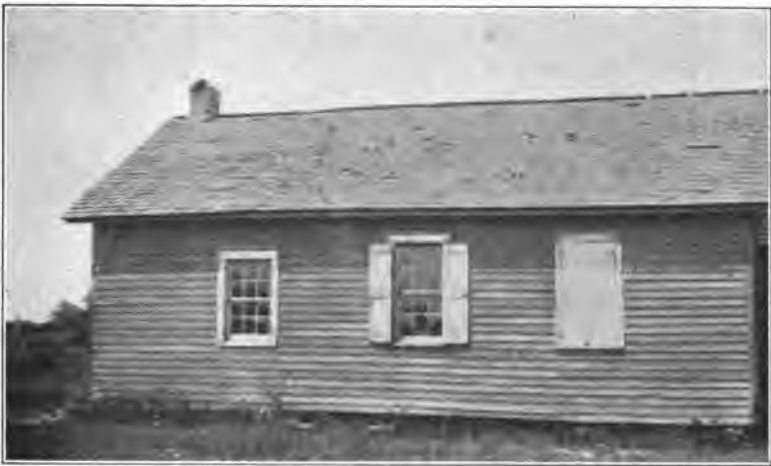
**BLANCO NO. 138**  
(Colored)

This is a one-room frame building, 18x30, with vestibuled entrance. The site is too small for present needs and is so located as not to be convenient of extension. The building scores but 19 points out of 250 on service systems and offers a minimum of class room facilities. The score by individual items and totals is sufficient justification for the recommendation that the building be abandoned.

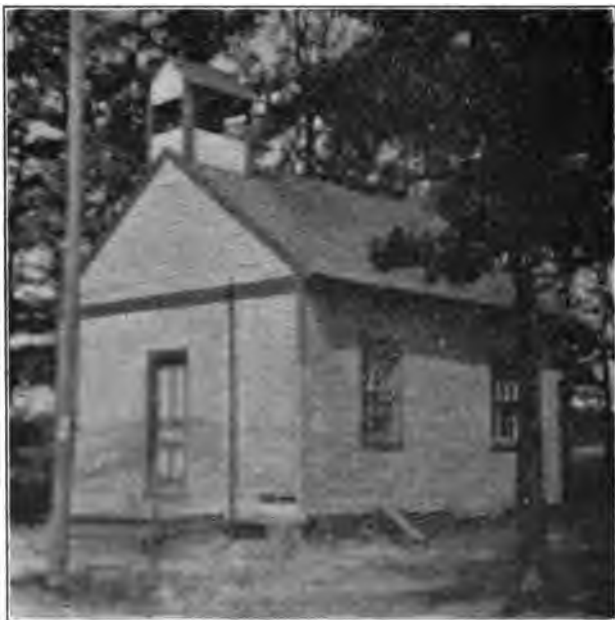
**SANDFIELD NO. 141**  
(Colored)

This is a very old frame building of the box type with open foundation. The building is 16x20, and the size of the site is indeterminate because of the fact that it is located in the woods, only the underbrush having been cut away to allow for the placement of the building. The elevation of the land is such that should this site be made permanent a large clearing would make a fairly desirable school site. The score of 30 out of 200 points on the building proper is indicative of the fact that little loss would be entailed in the complete abandonment of the building.

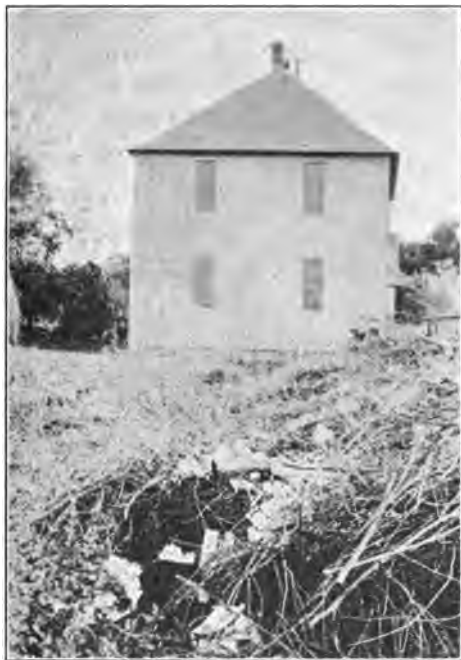
The Milford school is located on a limited site in close proximity to a very unsanitary dumpheap. The outhouses of this building were in the usual insanitary condition. The building itself is one of the better frame buildings provided for colored children in the special school districts. The rooms are poorly lighted, mainly from three sides. The floors are in bad condition and the equipment very poor. The plaster had fallen off in places. The building has no protection from fire dangers. Its awkward stairway, unequipped with proper handrails, and its class room doors opening inward, would add considerably to the danger to the lives of children who were endeavoring to leave this building in a hurry. The four rooms provided in this building cannot be considered adequate for the 140 children of eight grades who were registered here last year. No place was provided these children for hats or wraps and no conveniences of any kind were afforded teachers or pupils. The common drinking cup was still in use.

Colored school at Milford, Delaware. One of the best of the frame buildings provided for colored children in the special school districts. It is unfortunate that the dumpheap is in such close proximity to this school. The outhouses for this building were in the usual insanitary condition. The site is small and no conveniences provided for teachers or pupils. This four-room school will not provide the type of education that children of a democracy ought to be getting.

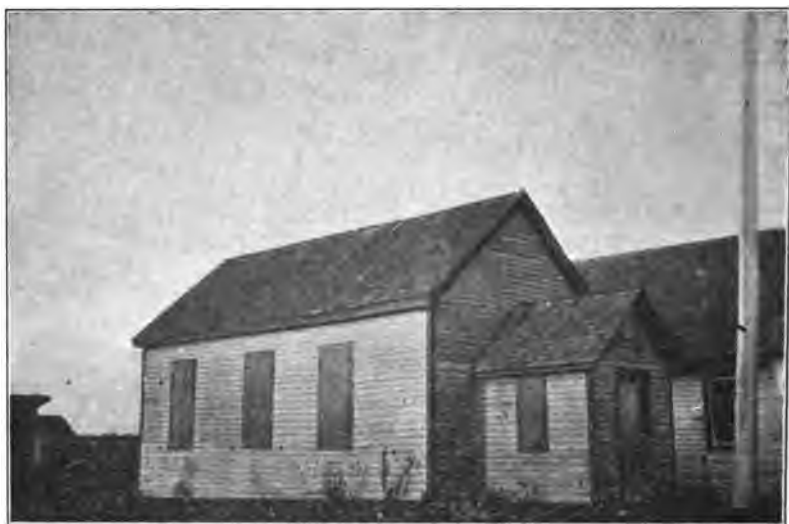
**ELLENDALE SCHOOL**

This is a very old, one-room, vestibuled frame building, 14x28, on a brick foundation in very bad condition. It is located in a churchyard and offers little opportunity for play or recreational facilities. Service systems are either entirely missing or of the most meager type possible. The class room is small, dirty and in general uninhabitable. The glass area is low and distributed on

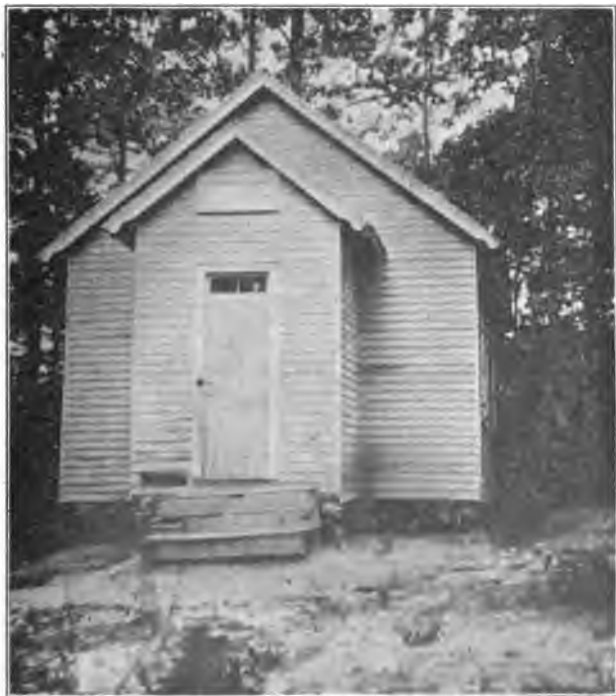
**MILLSBORO SCHOOL**

This is probably as poor a school building as can be found in

Delaware. Its score of 111 points indicates that practically nothing exists about this school which is worthy of mention. Torn, ragged, out-of-date maps are samples of the type of equipment. A floor full of holes and patched in places by nailing on a second layer of broken board indicates in what condition the interior of this structure was found. Weeds were actually growing through the floor of the schoolhouse. The majority of the blackboards were painted wooden boards with a large part of the paint worn off. The building is located in what was once a clearing on a forest road, in the midst of a dense forest. The clearing had become overgrown to such an extent that it was impossible to see the outhouses, if there were any, from the road. The State of Delaware should not permit this building to be used as a schoolhouse a moment longer than it will be necessary to build a high-grade, modern plant for these children.

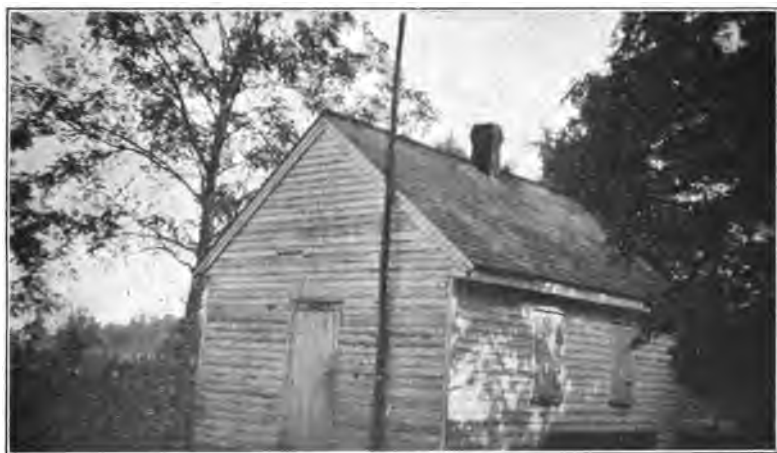
**WHARTON SCHOOL**

ular site, approximately 100x150 feet, surrounded on three sides by oak woods and underbrush. The building is 14x20, of the non-vestibuled type, lighted from three sides with the seatings so arranged as to compel the children to face an open window. The entire structure is in the last stages of decay. From the exterior one would never suspect that school children would be housed in such quarters. The

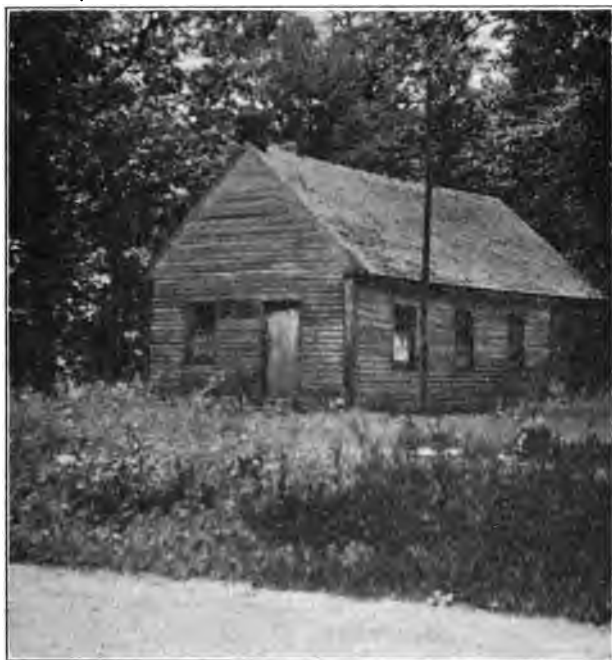
**TRINITY SCHOOL**

This building is a one-room frame structure, without vestibule. It is approximately 18x32 feet in dimensions. The character of the foundation could not be ascertained without the removal of boards, which were buried in the ground. The roof is moss-grown, and the entire building is in the last stages of decay. It is located in a churchyard at the intersection of poorly graded, unimproved roads. The building is heated by a box stove. It has neither clock nor bell; no provision has been made for either drinking or washing facilities and no toilet accommodations whatever are provided. The glass area of the class room is less than one-half of what it should be, and what it has is distributed on opposite sides of the room. No window shades are supplied and no provision made for cloak rooms. The only commendable feature of the building is the new double desks which have been installed. These are in good condition, but double desks do not meet standard requirements. This building

should be abandoned absolutely and the children of the community provided with a new and modern schoolhouse.
